**Tesla, Inc.**  
Service Bulletin

## Tighten Front Frame Rail Bolts

**SB-24-10-002**

January 23, 2024

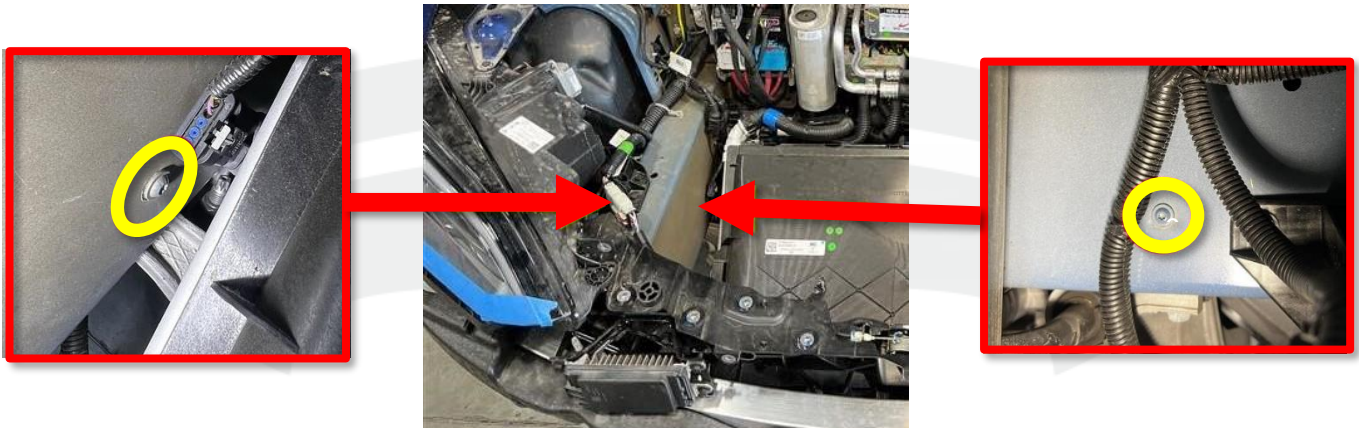
**Figure 1 – Bolt locations, RH front frame rail**

On some Model S and Model X vehicles, the LH and RH frame rail bolts might not have been tightened to specification, which could result in a creak or rattle noise coming from the front of the vehicle while turning the steering wheel at low speeds. This condition does not affect the structural integrity of the vehicle.

2. Tighten the T25 bolts (x2) that attach the inner and outer threaded inserts on the RH front frame rail (Figure 1) (torque 7 Nm).

3. Mark the bolts with a paint marker after they are tightened.
4. Repeat step 2 on the LH front frame rail (Figure 2).
