**AUTOMOTIVE TAIL
LIGHT ASSEMBLIES
MODEL: 03SDBTBK/03SDBTRD**

AUTOMOTIVE TAIL LIGHT ASSEMBLIES

MODEL: 03SDBTBK/03SDBTRD

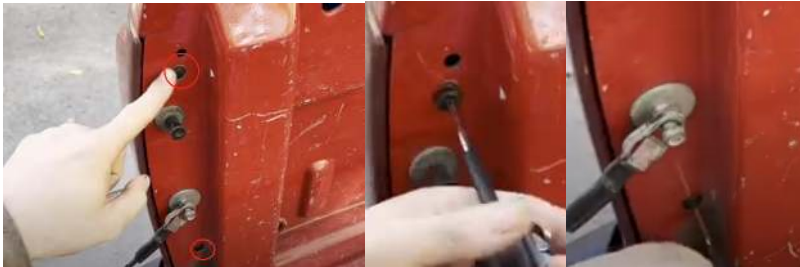
1. Open the tailgate ,remove 2 mounting screws.

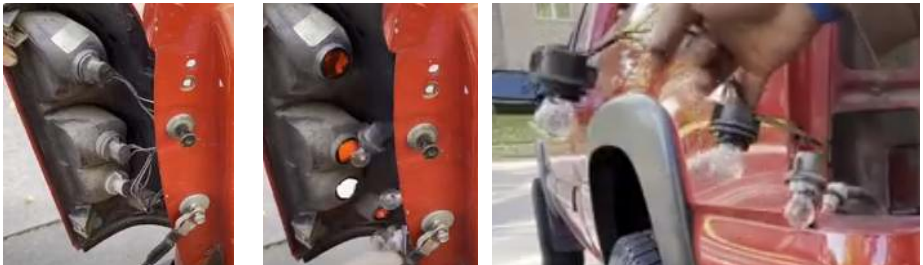
2. Remove the original factory taillight assembly, and all taillight sockets and bulbs (Note: The original reversing lights need to be retained and installed on the new lights).

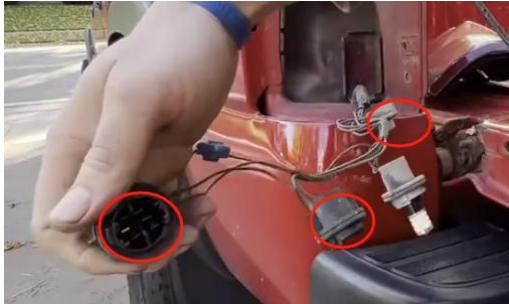
3.Remove all the light bulbs except the original reversing light bulb of the car.

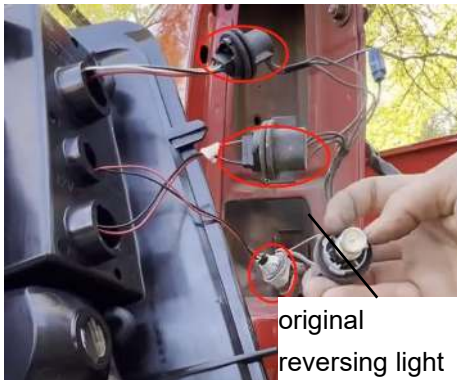
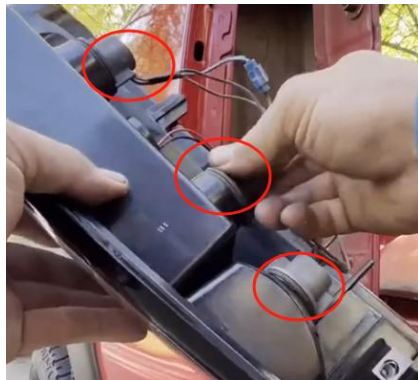
original
reversing light

1.Connect the harness terminal of the new light to the terminal block of the car(except for the original reverse bulb).Then screw the harness terminal base into the lamp house.

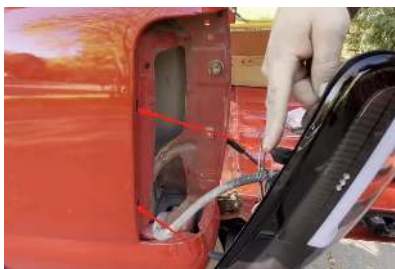
2.Locate taillight assembly,Connect taillight harness,Seat taillight assembly in place.Test our light make sure everything works as it should.

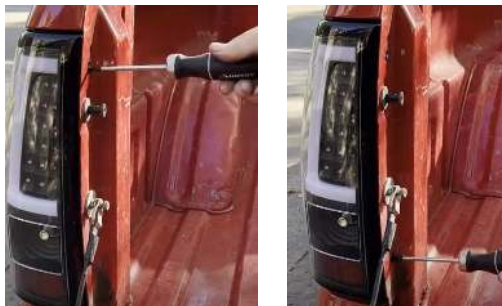
3.Reinstall 2 mounting screws.

※The above figure shows the replacement of only one of the models, the operation process is similar for other models.
